# Racked in Oskarshamn

150915, Fredrik, Jönköping

# Norra vägen Oskarshamn

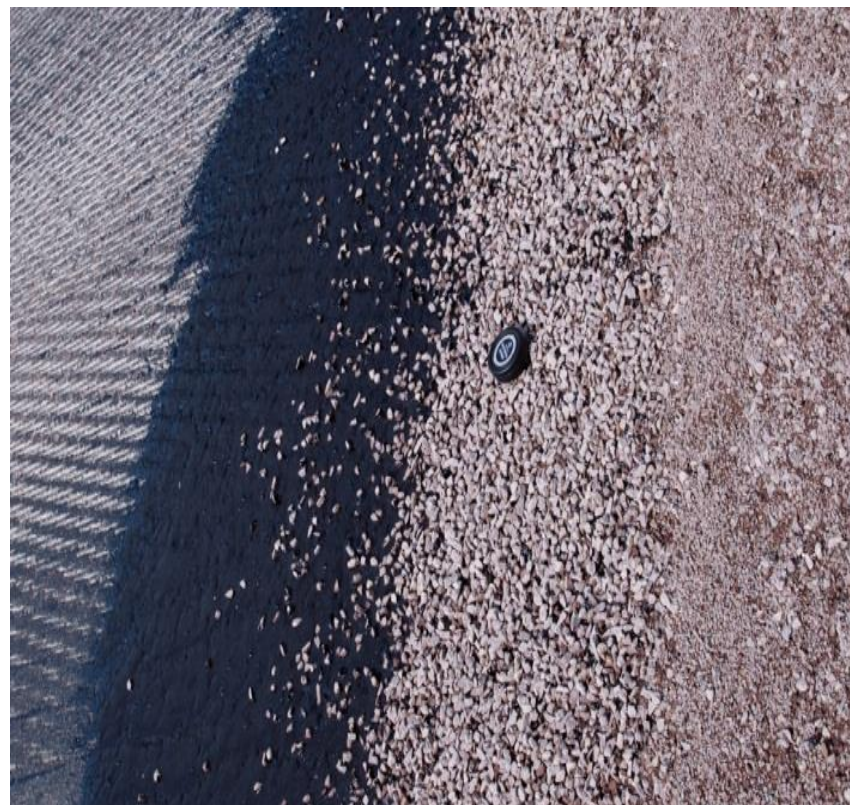
# Underlaget för ytbehandlingen

- ▶ Ytan fräst en vecka före ytbehandlingen.
- ▶ Fräsningen omfattade inte hela ytbehandlingsbredden.
- ▶ Extra sopning utfördes innan ytbehandling.
- ▶ Lösa partiklar fortfarande på ytan.

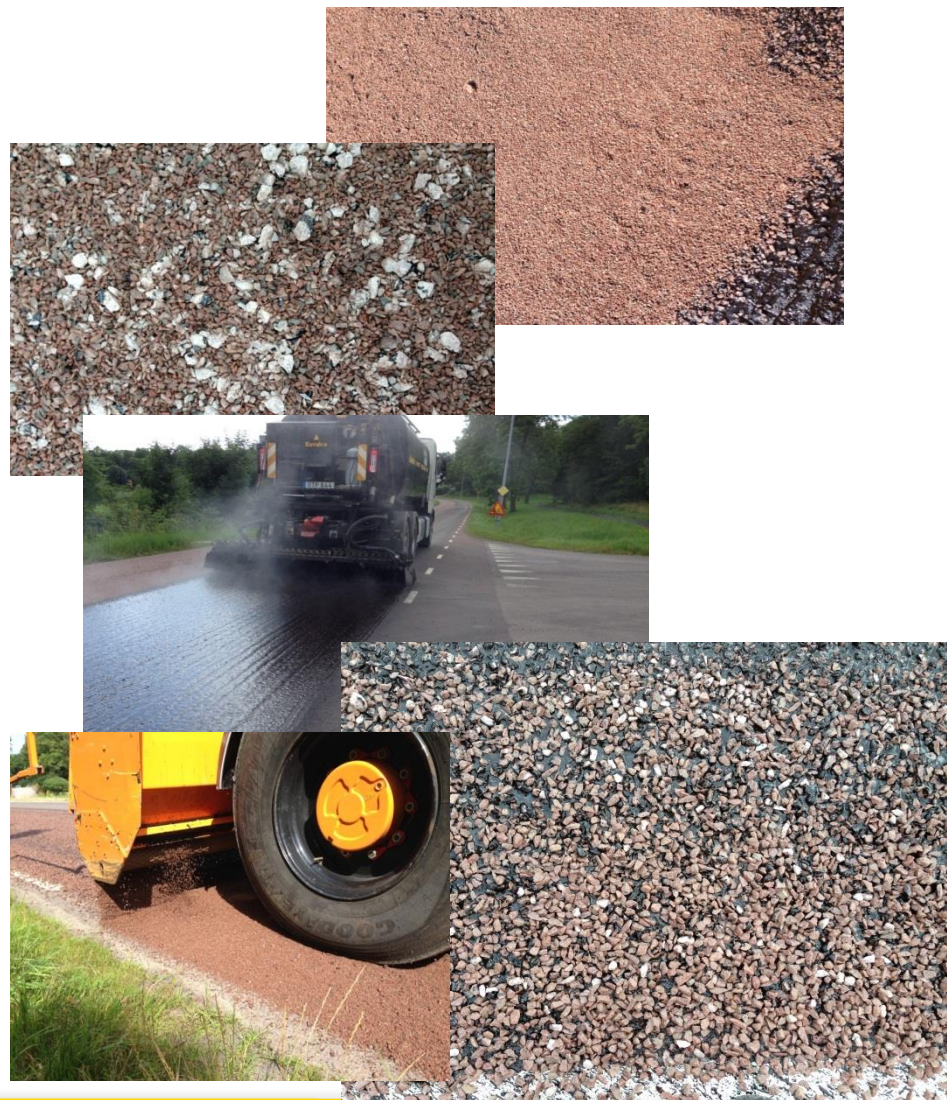
# Spridningsmängder

- ▶ Emulsion mängd 2.1 kg/m<sup>2</sup>
- ▶ Fraktion 8/11, ca. 11 kg/m<sup>2</sup>
- ▶ Fraktion 2/5, För mycket under första delen av dagen, 8.5 kg/m<sup>2</sup>. Justerad under eftermiddagen till ok.

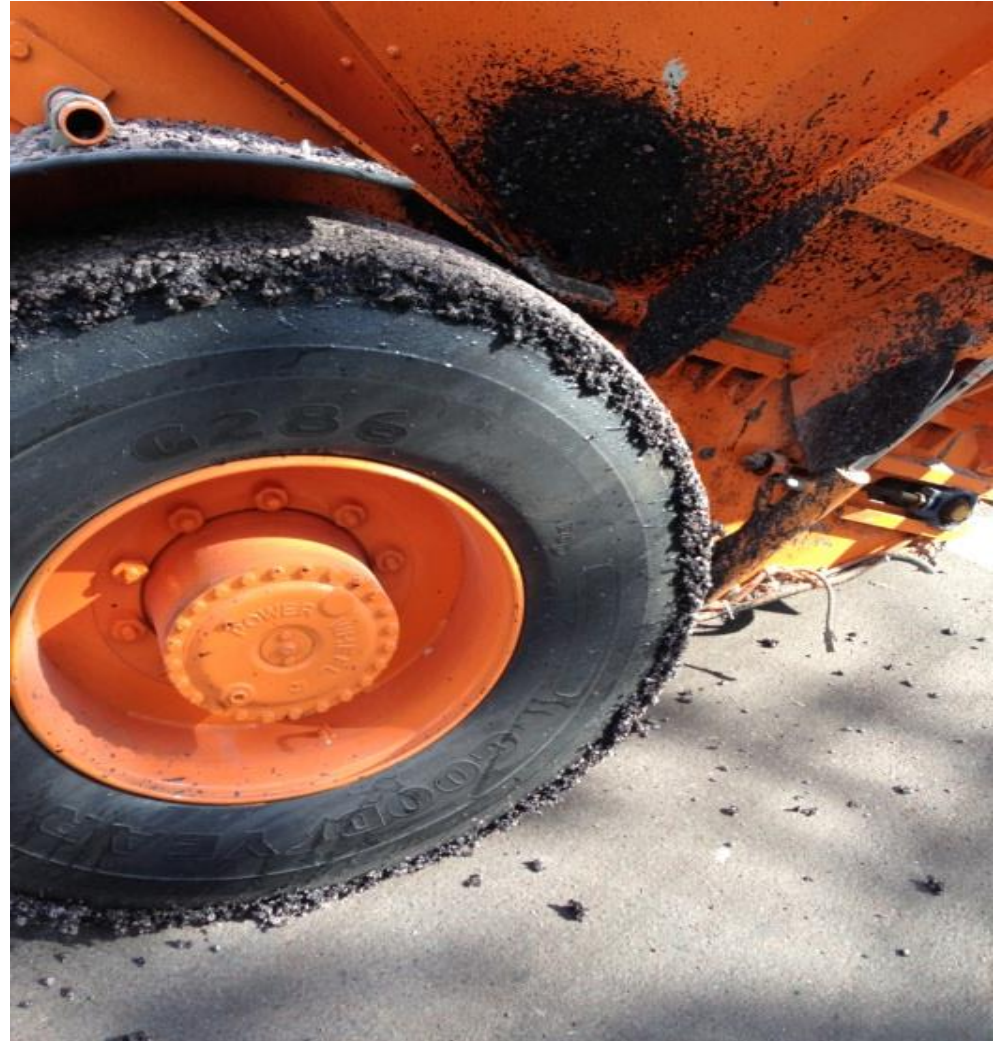
# Stenplockning

- Stenmaterial fastnade på hjulen. Tilltagande under dagen men hanterbart.

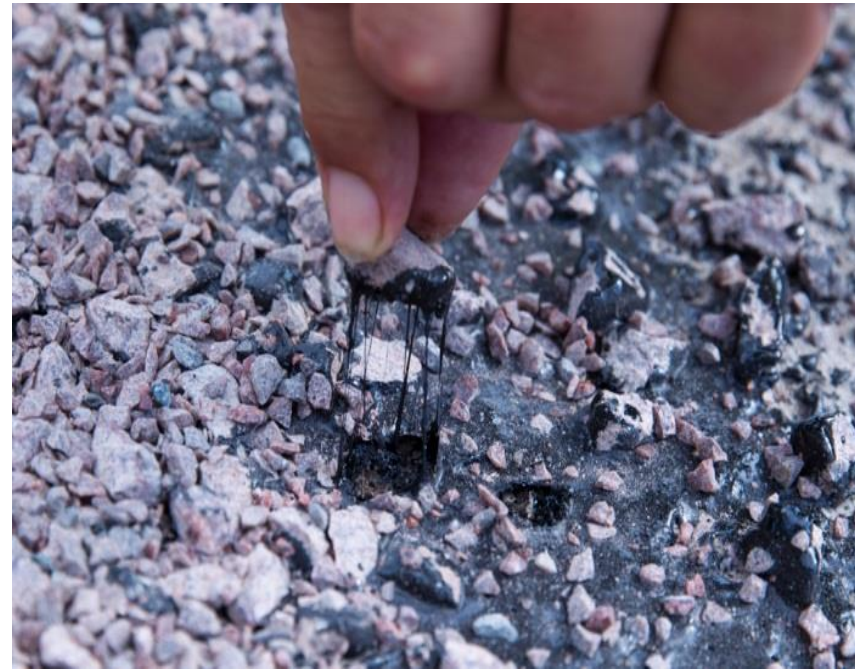
# Emulsionsbrytning

- ▶ Långsam brytning.
- ▶ Trådar efter 5-6 timmar.
